# BRVKENTHAL ACTA MVSEI

## XIII. 4

Sibiu / Hermannstadt, 2018

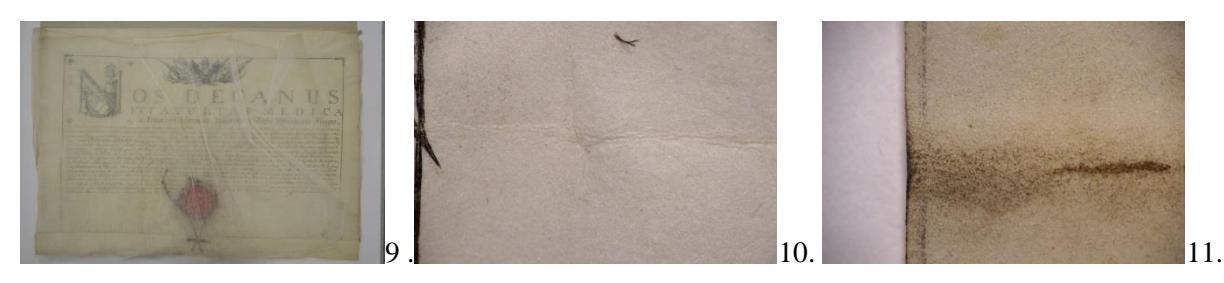
9. Diploma covered by Japanese paper tissue at laboratory entry

10. Macroscopic aspects of the degradation of the parchment - detail of the folding lines

11. Macroscopic aspects of degradation of the parchment - folding line detail, uneven deposition of dirt

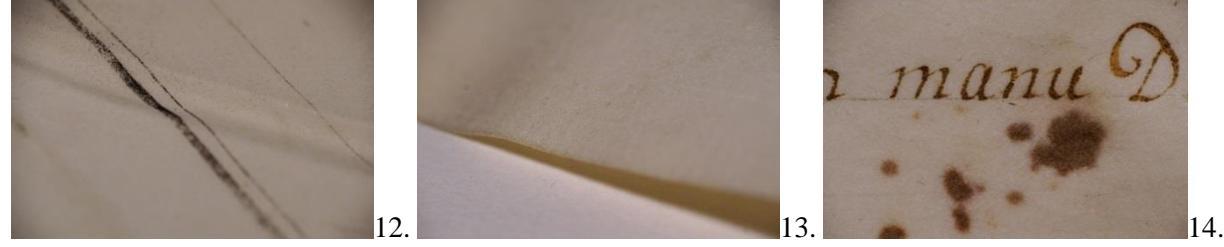
- 12. Macroscopic aspects of the degradation of the parchment cockleing, tide lines
- 13. Macroscopic aspects of parchment degradation cockleing
- 14. Macroscopic aspects of parchment degradation front side detail, brown-red spots

Besides the folding lines, the parchment support, also, had planar deformations in extended areas, where were identified sections with visible shrinkage of the support, and sections where cockling occurred due to high humidity. There have also been found deposits of uneven soiling and accretion, different hues stains of unknown origin, tide lines. We noticed the reduction of text legibility in certain areas. Ink signature validation was discolored. The wood of the seal casing exhibits insect exit holes. The wax seal is cracked and has deposits of dust and dirt. The seal cord showed small tears with and without loss of material (Fig.10-19).

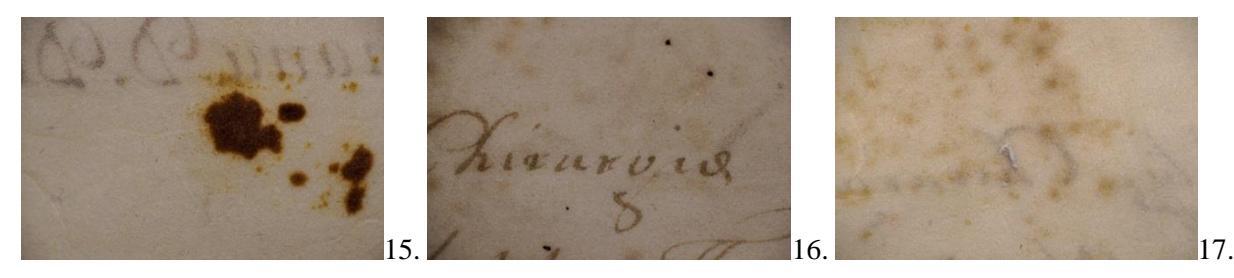
- 15. Macroscopic aspects of parchment degradation back side detail, brown-red spots
- 16. Macroscopic aspects of parchment degradation front side detail, brown-red spots
- 17. Macroscopic aspects of parchment degradation back side detail, brown-red spots

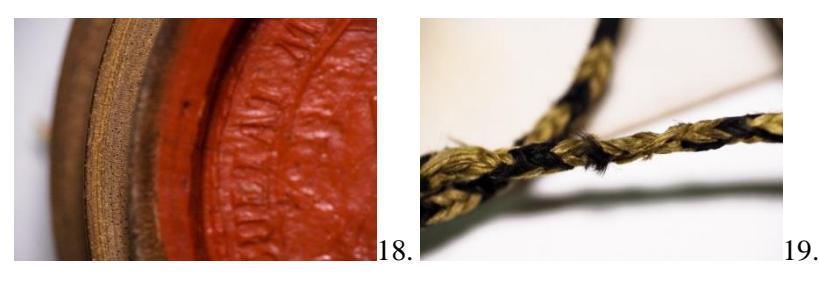
- 18. Macroscopic aspects of seal degradation detail, exit holes
- 19. Macroscopic aspects of textile cord degradation detail, small ruptures with and without loss of material

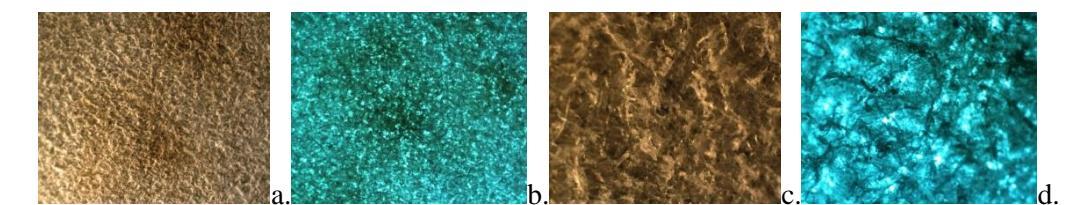
27 Microphotographs of the stained area located above the bottom writing on the back of the document: a. Microscopic appearance in direct light - 40x, b. Microscopic appearance in ultraviolet light - 40x UV, c. Microscopic appearance in direct light - 160x , d. microscopic appearance in ultraviolet light - 160x UV.

As far as the brown stains, on the surface of the document's back, in the lower right-hand area under the writing, the microscopic aspects indicate that it penetrated the depth of the parchment support, affecting its structure. This can be seen in details obtained in direct light, especially in those obtained in ultraviolet light, at forty times (40x), one hundred times (100x) and one hundred and sixty times (160x). Fig. 27, a, b, c, d.

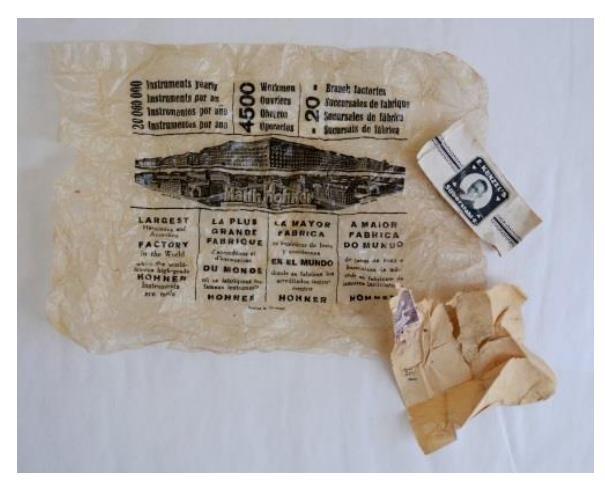
2. The preservation condition of the three items at their discovery.

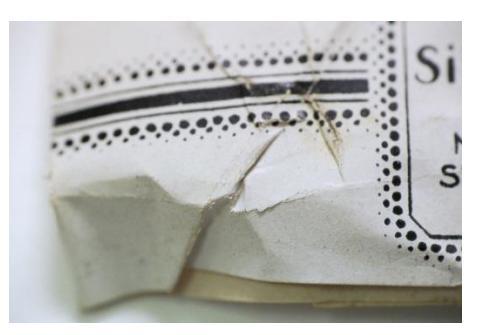
5. Item A before conservation (verso). Detail: mechanical degradations.

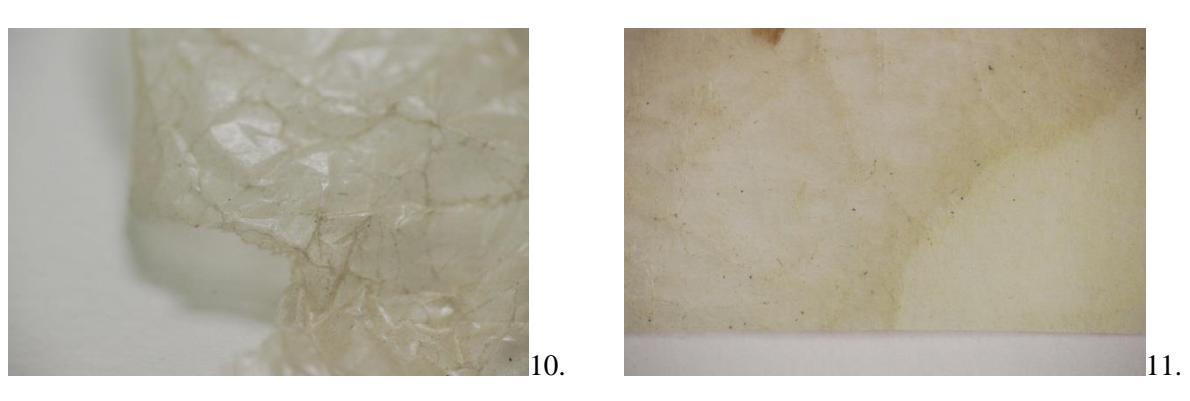
10. Item B before conservation. Detail: mechanical degradations.

11. Item B after conservation. Detail: area completed with Japanese paper.

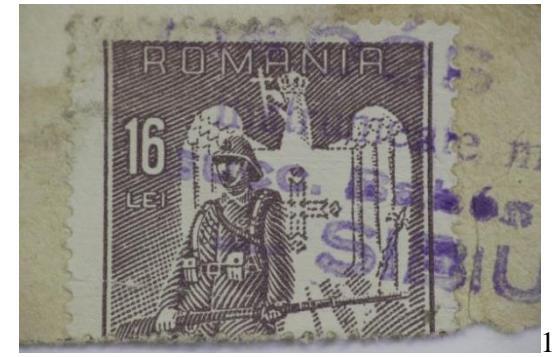
16. Item C before conservation (recto). Detail: degradations of the revenue stamp and of the paper support. 17. Item C after conservation (recto). Detaliu.

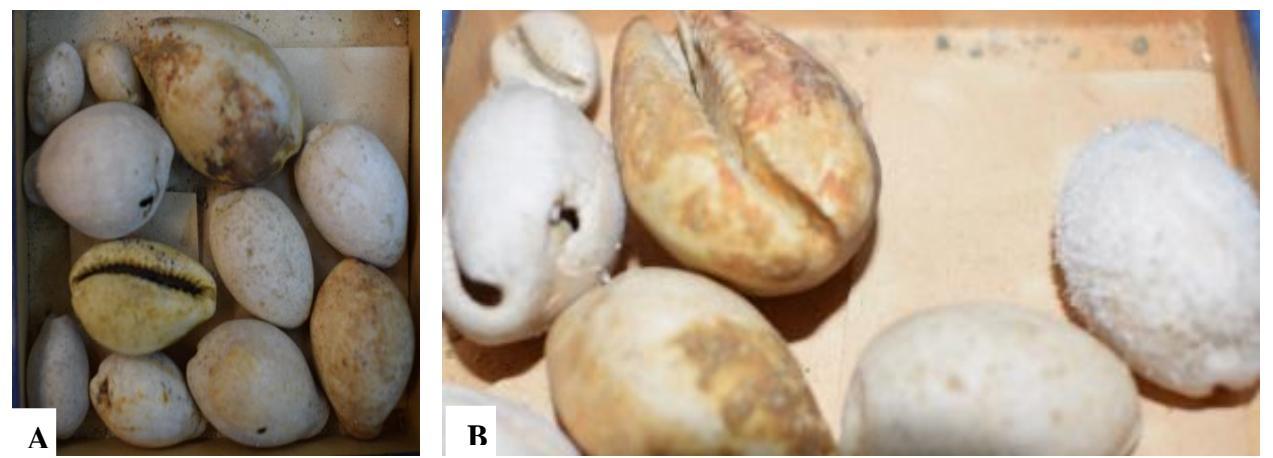
1. Inv. no. 40.808-40.818. Aspect before restoration: A, B - Crystalline deposits, traces of clayey/sandy substrate, holes, cracks in shells.

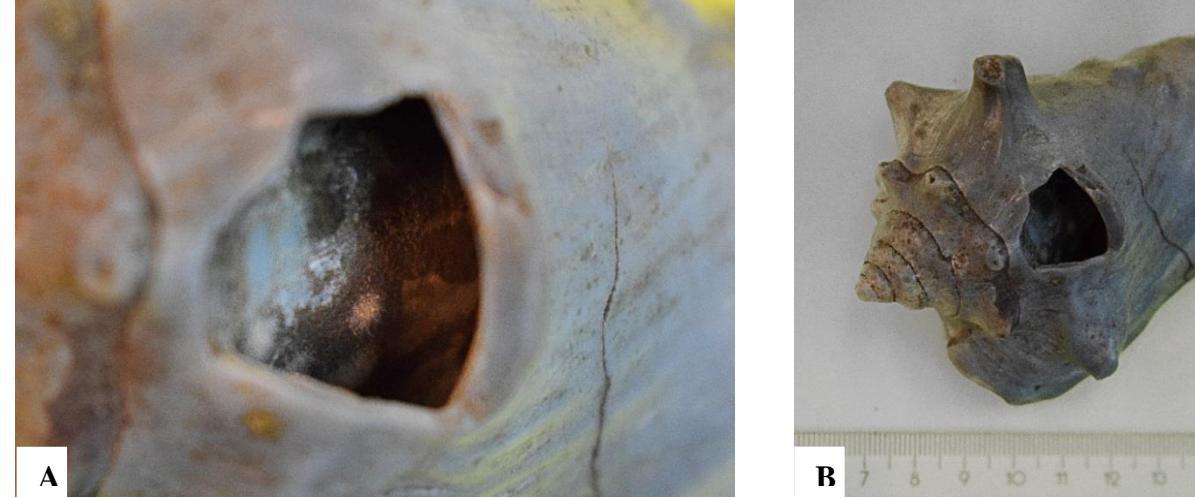
7. Inv. no. 40.844. A - Detail of biological degradation inside the shell, crack on the right, B - Overview before restoration.

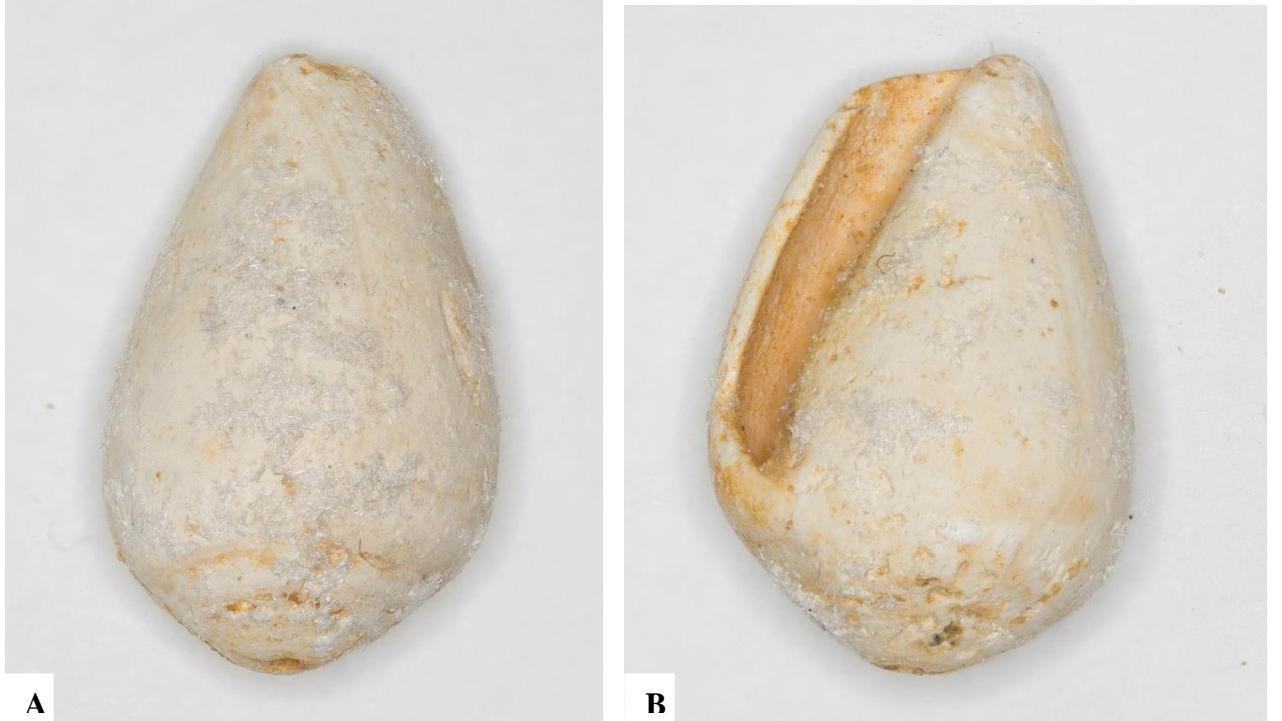
9. Inv. no. 41.426-41.429. A, B - White crystalline deposits (Byne Disease).

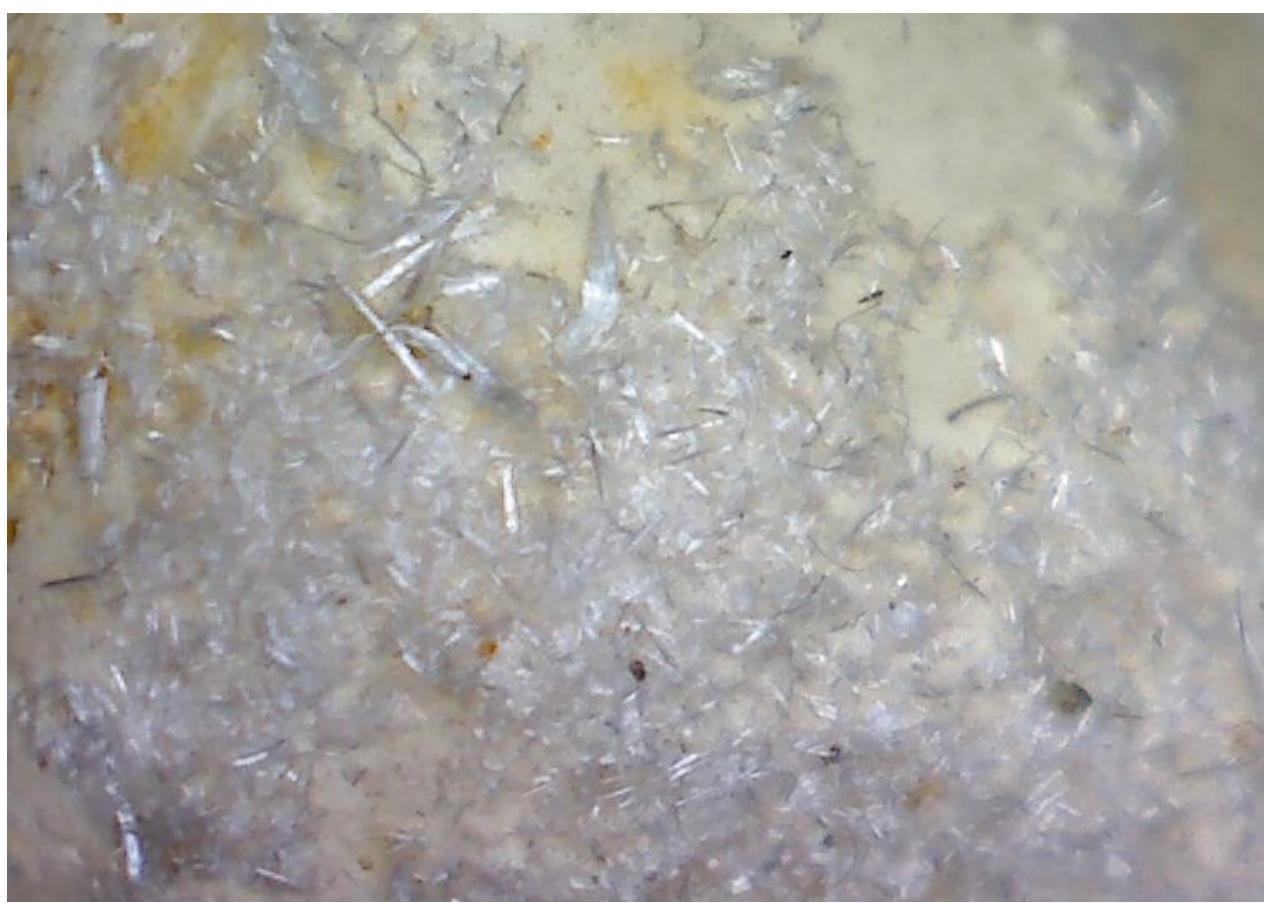
10. Inv. no. 41.426-41.429. Microscopic detail - Byne Disease: calcium acetate.

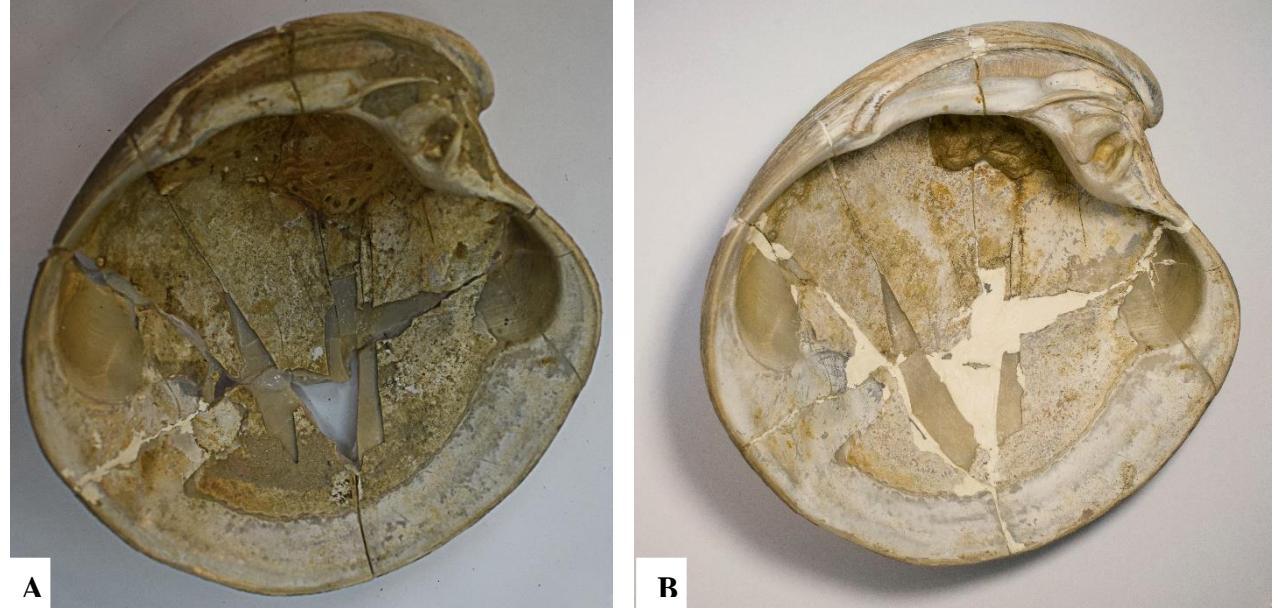
14. Inv. no. 32.289. A, B - Appearance during restoration interventions (fixing fragments, filling the lacunas).

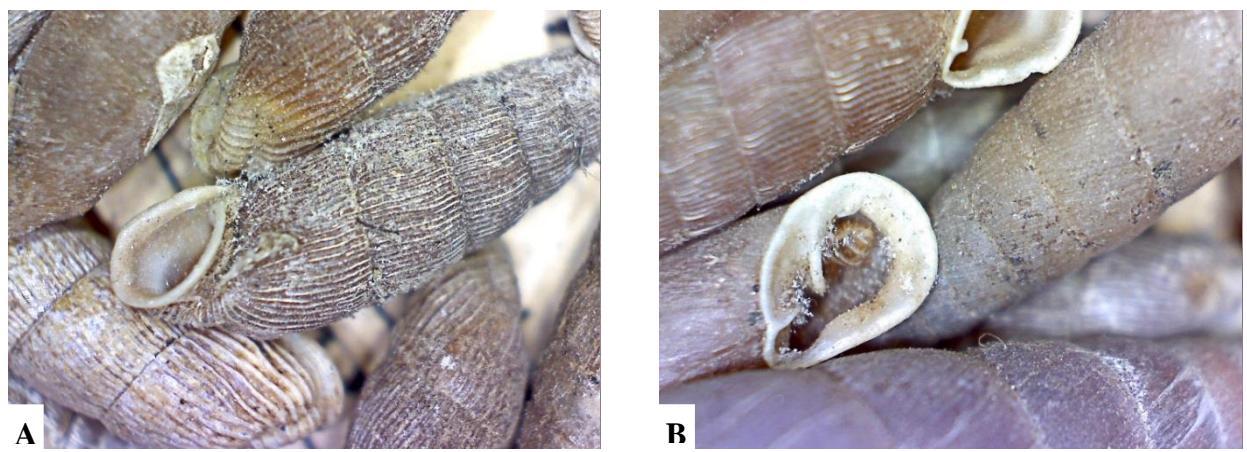
22. Details before restoration: A - Inv. no. 205.111-205.143 - Mold, B - Inv. no. 205.144-205.204. Mold, body of insect in the shells

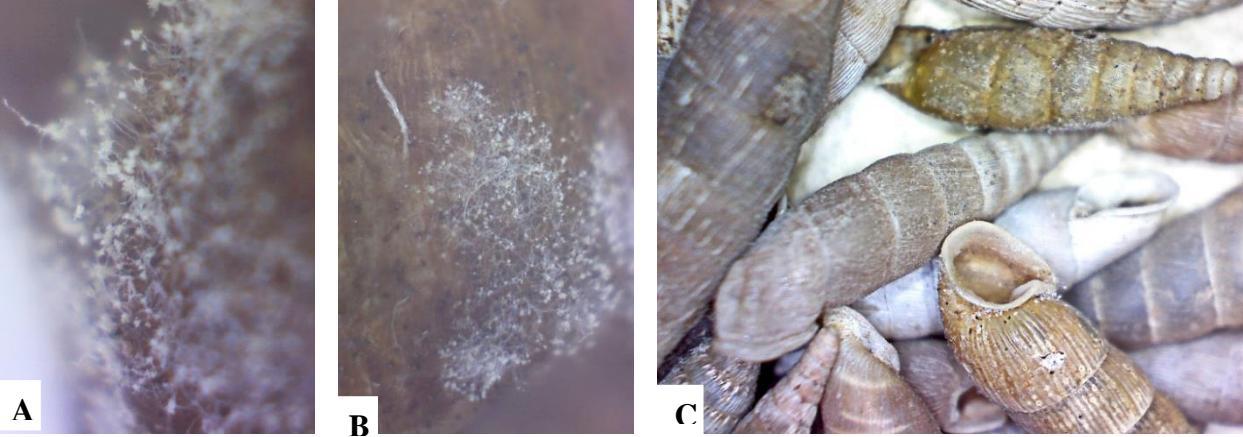
23. Microscopic details before restoration: A, B - Inv. no. 205.205-205.242. Molds, C - Inv. no. 205.618-205.655. Appearance changes.

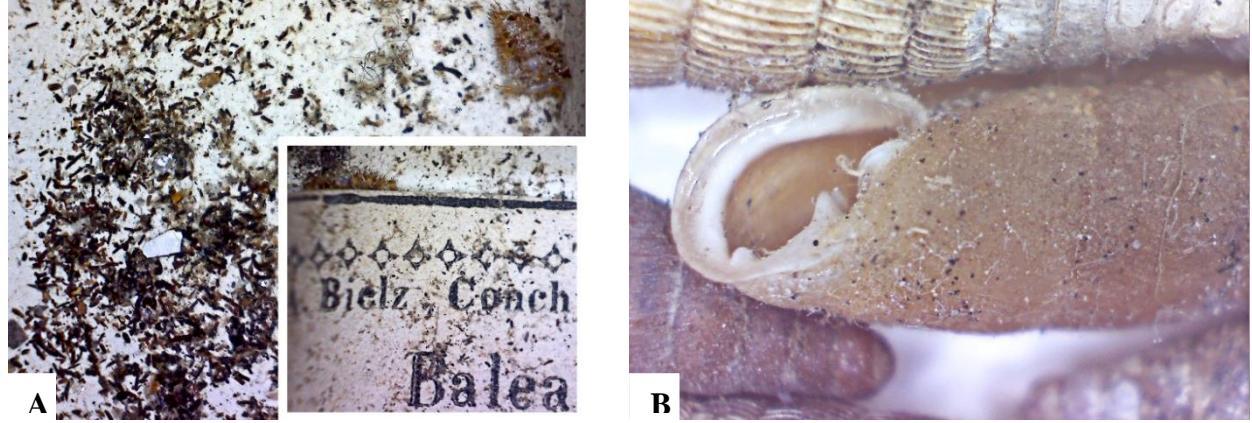
24. Inv. no. 205.658-205.681. Microscopic details: A - The box and the label: bodies of insects pests, B - Deposits of dust, mold.

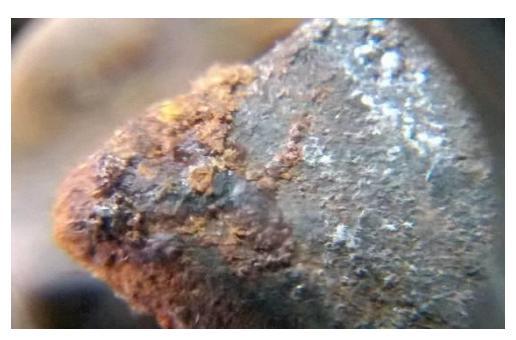
8. Product of corrosion

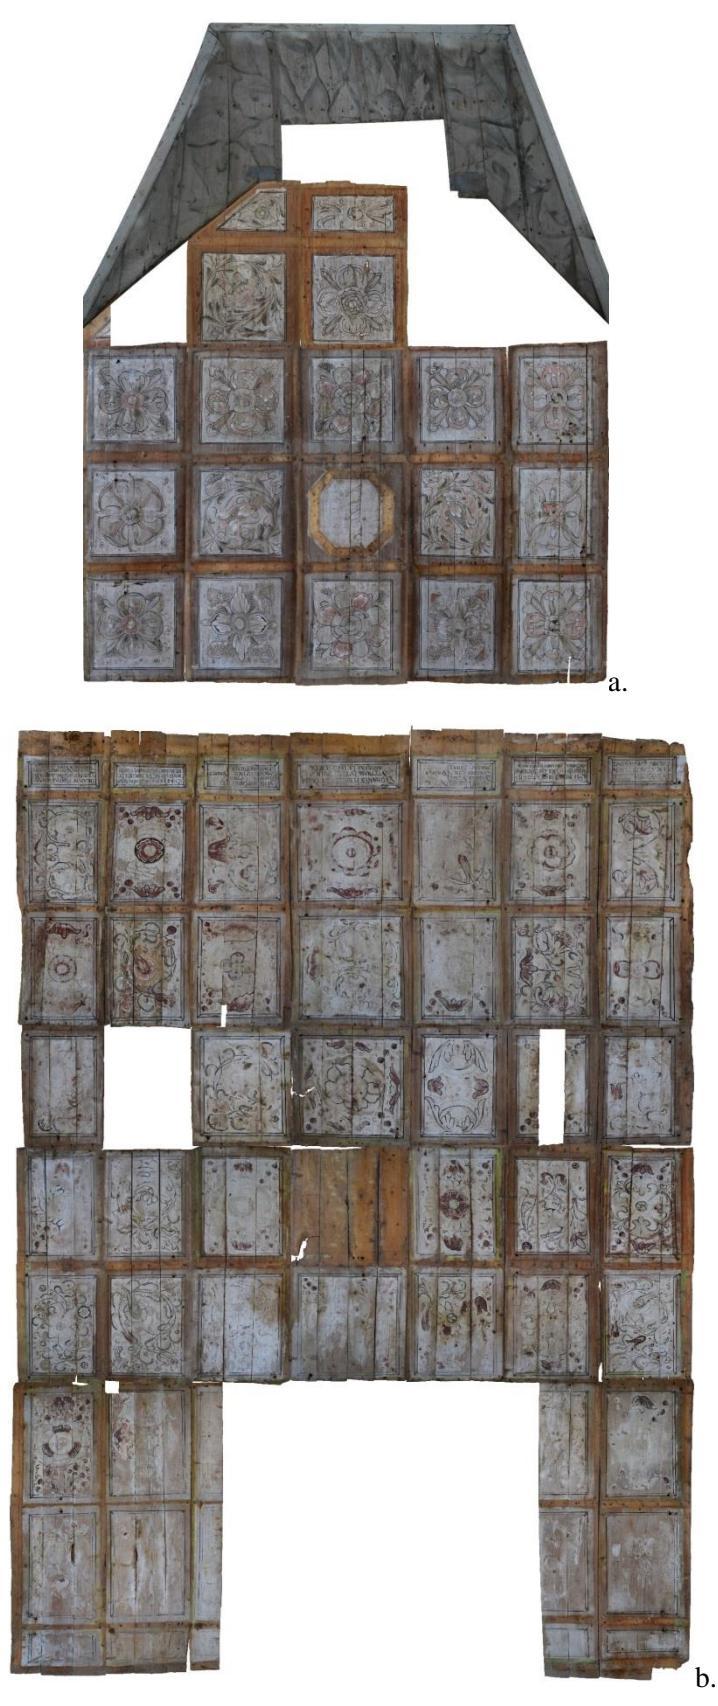
24. a, b. Ensemble of the painted layer and color loss
